REPORT DOCUMENTATION PAGE		READ INSTRUCTIONS BEFORE COMPLETING FORM
1. REPORT NUMBER VA 16303	2. GOVT ACCESSION NO.	3. RECIPIENT'S CATALOG NUMBER
4. TITLE (and Subtitle) Phase I Inspection Report National Dam Safety Program ROBERTSON DAM ROCKBRIDGE COUNTY, STATE OF VIRGINIA		5. TYPE OF REPORT & PERIOD COVERED 9 Final rept

NAME OF DAM: ROBERTSON DAM

PHASE I INSPECTION REPORT
NATIONAL DAM SAFETY PROGRAM
NAME OF DAM: ROBERTSON DAM ID# VA 16303

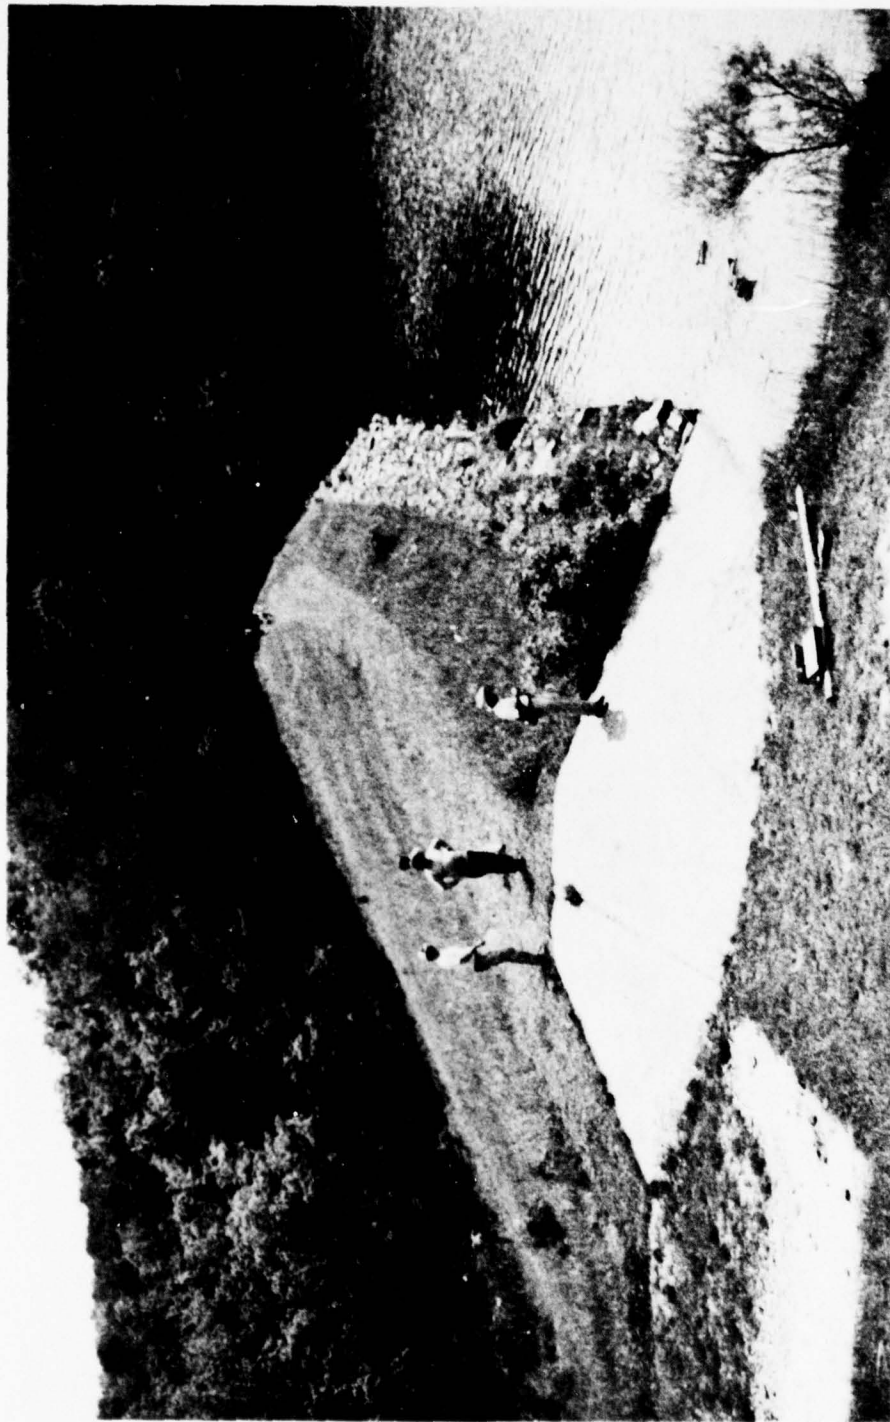
OVERALL VIEW OF DAM

A few small trees are growing on the embankment. The most significant are rooted at the edge of the concrete slab protecting the embankment in the emergency spillway (see Overall View of Dam). These trees could loosen the soil of the upstream slope and allow water to undercut the slab during high water periods.

Other items discovered during the inspection which should be corrected as part of the general maintenance are: repair rodent holes, add additional riprap to the left end of the upstream embankment, remove trees from the embankment and emergency spillway, repair corner of the concrete apron near the outlet pipe, repair erosion on the embankment and emergency spillways, and install a staff gage in the reservoir.

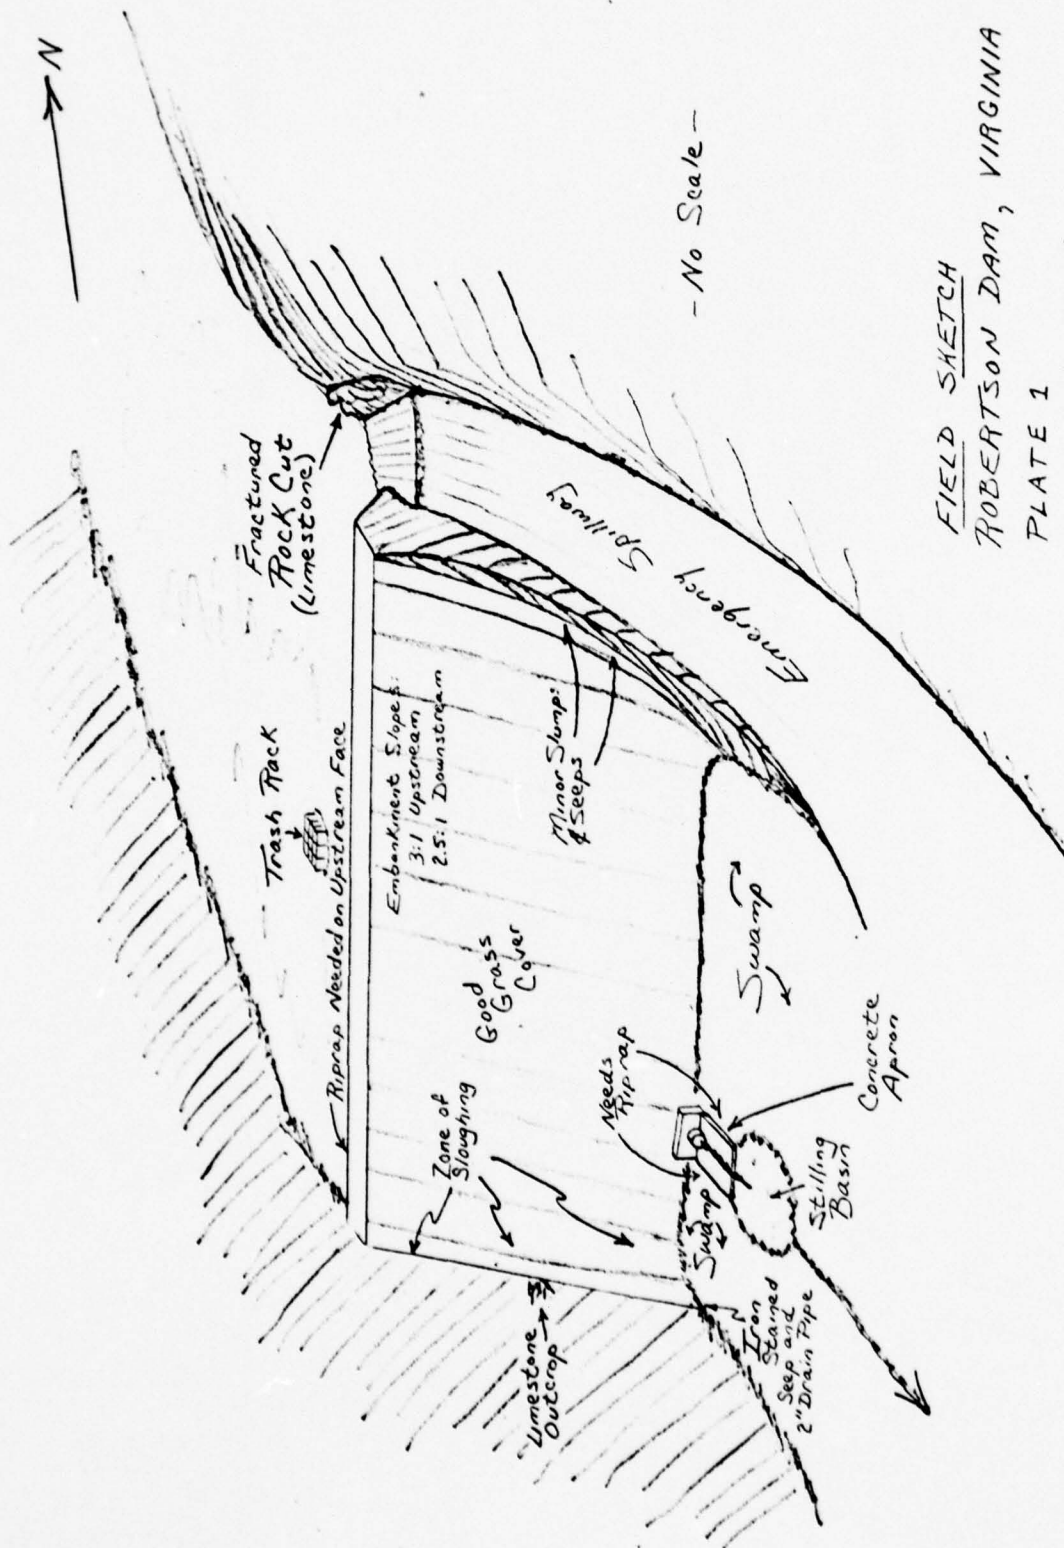
FIELD SKETCH
ROBERTSON DAM, VIRGINIA
PLATE 1
Michael Baker, Jr., Inc.
5 June 1979

Plate 1 is a Field Sketch of the dam as built which depicts the conditions found during the inspection. The complete visual inspection check list is included in Appendix III. Following are brief summaries of the deficiencies noted during the inspection.

discharge channel, minor slumping has occurred (see Plate 1). Clear seeps (too small to measure) are occurring in this area which are probably related to bedrock springs. This assumption is supported by the presence of a spring which was noted during the planning stage. The spring is at approximately the same elevation as the bedrock outcrop on the left abutment and just upstream of the dam centerline (see bedrock and spring indicated in the left abutment area on Plate 2). Surface runoff and a few animal burrows are aggravating this condition.

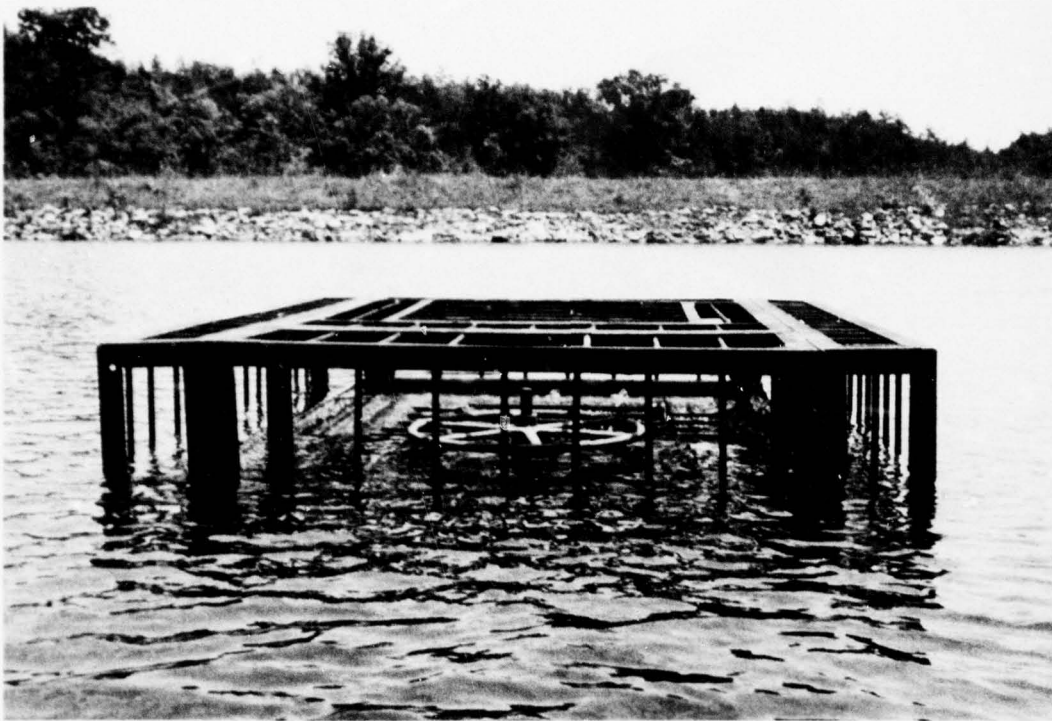
PHOTO 1. Principal Spillway Head Tower with Sluice Gate Hand Crank

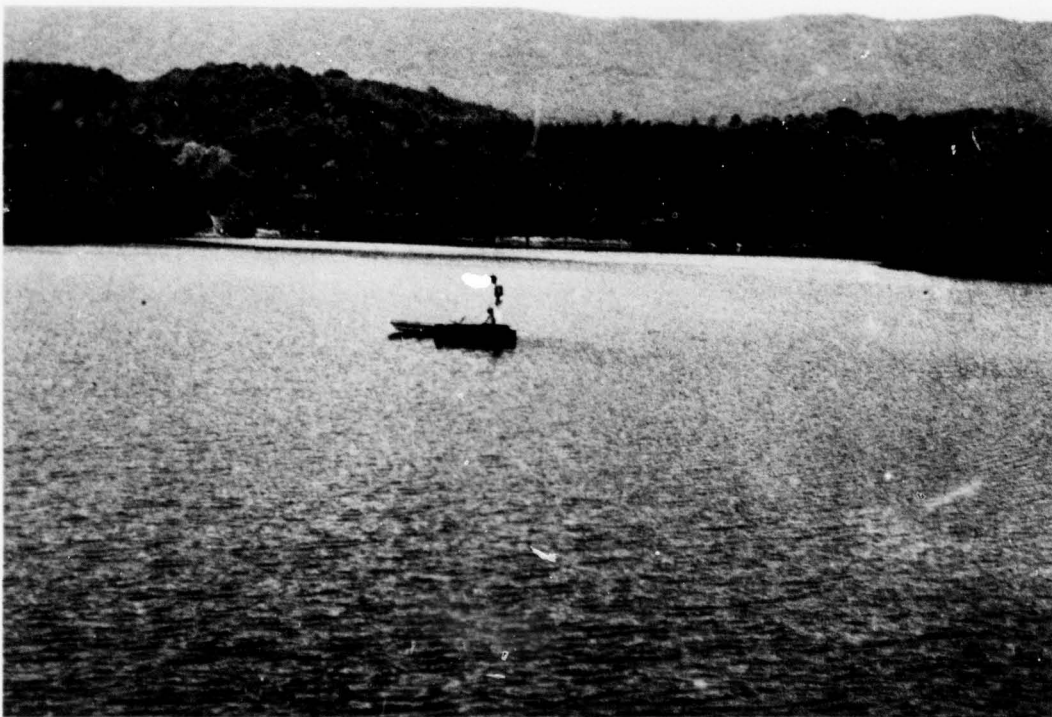
3.1.4 Reservoir Area: No apparent unstable areas were noted in the reservoir area. The slopes are moderately steep and heavily wooded (see Photo 2). One sinkhole was observed on the eastern reservoir slope immediately upslope and adjacent to the footpath which circles most of the reservoir.

PHOTO 2. Slopes and Vegetation Surrounding Reservoir

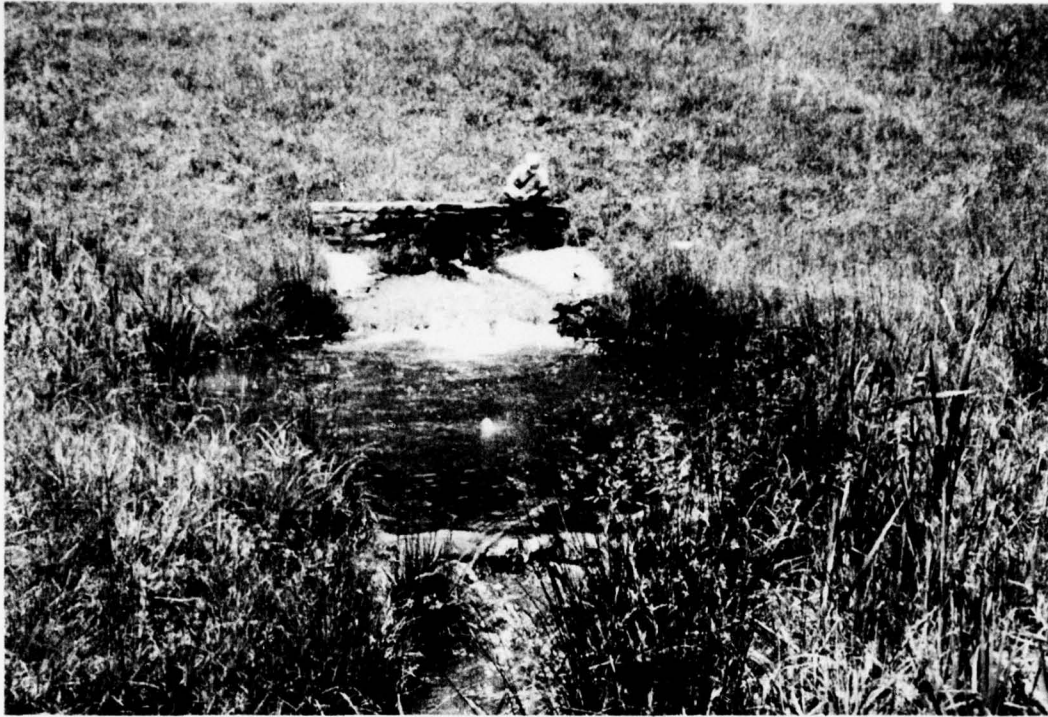
Appurtenant Structures: Minor erosion and a few unvegetated areas were observed in the discharge channel of the emergency spillway. The left downstream corner of the concrete apron, onto which the dam outlet pipe discharges, has begun to deteriorate. Insufficient riprap surrounds the upstream sides of the stilling basin and the outlet structure to provide protection for the toe of the dam (see Photo 3 and Plate 1).

PHOTO 3. Principal Spillway Outlet and Stilling Basin

- 1) Excavate, fill, compact, and seed rodent holes in the embankment.
- 2) Repair the corner of the concrete apron near the outlet pipe.
- 3) Excavate, fill, compact, and seed the slumped area at the junction of the embankment and the emergency spillway discharge channel. Also, provide riprap in the gutter to prevent erosion from surface runoff.
- 4) Add additional riprap on right end of the upstream embankment to prevent erosion.
- 5) Remove small trees from the embankment and emergency spillway.
- 6) Repair and seed erosion damage on the embankment and emergency spillway.
- 7) Install a staff gage to monitor reservoir levels above normal pools.

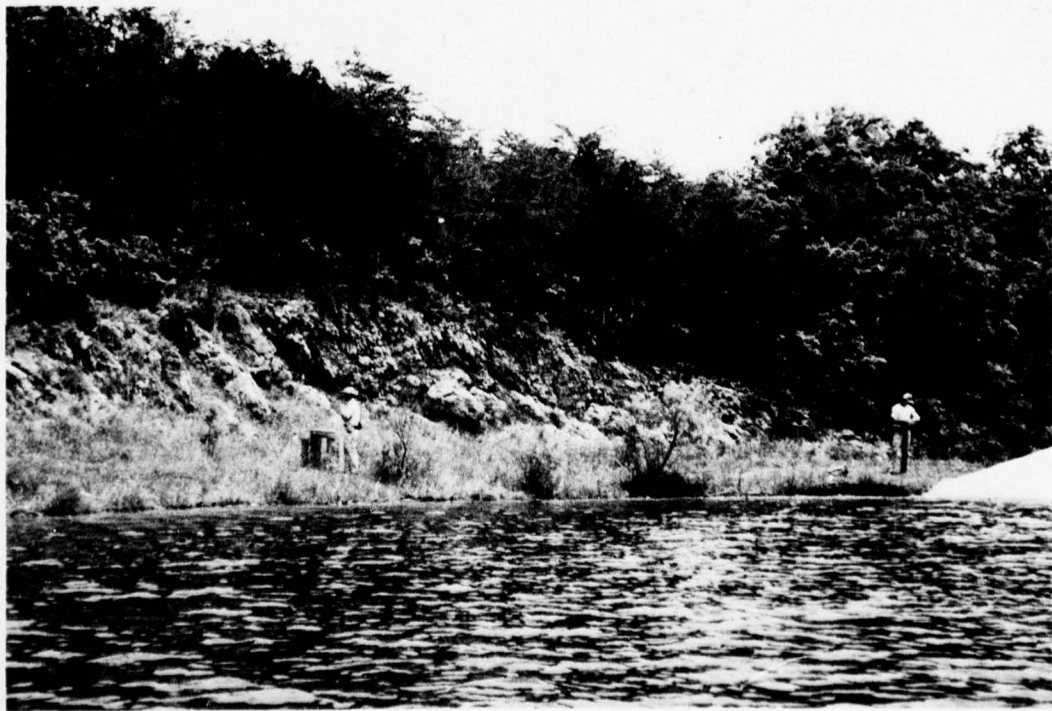
The limestone exposed in the bedrock cut of the emergency spillway is folded and highly fractured (see Photo 4). Two small cavernous areas or solution channels were also detected in this exposure.

PHOTO 4. Upstream View of Emergency Spillway

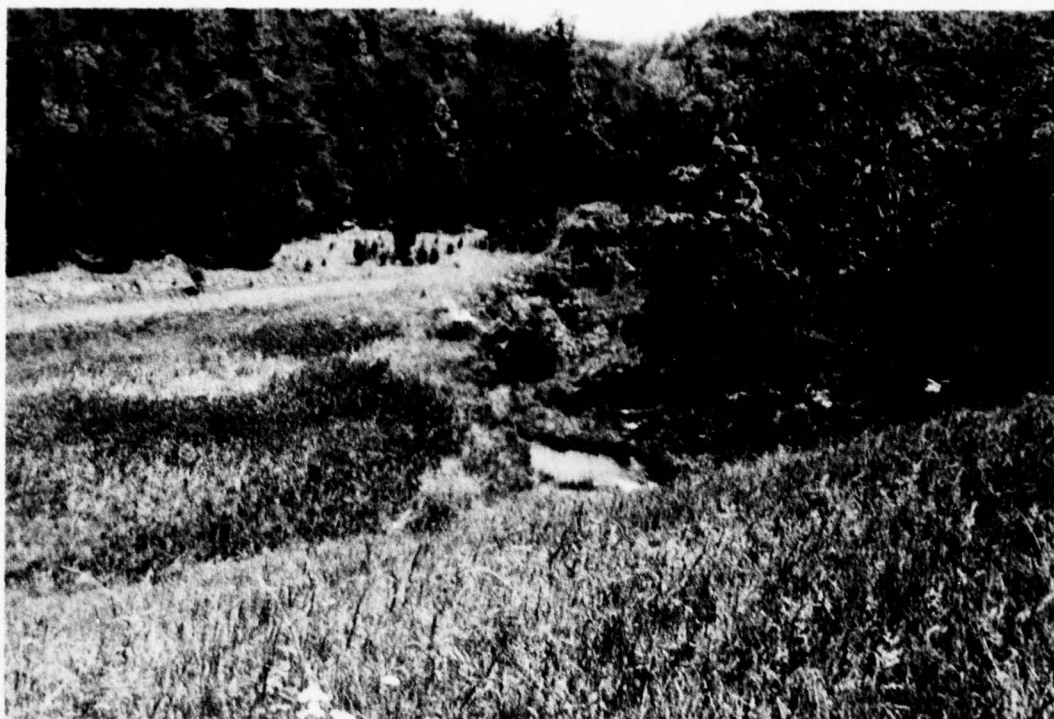
PHOTO 5. View of Downstream Channel from Dam Crest

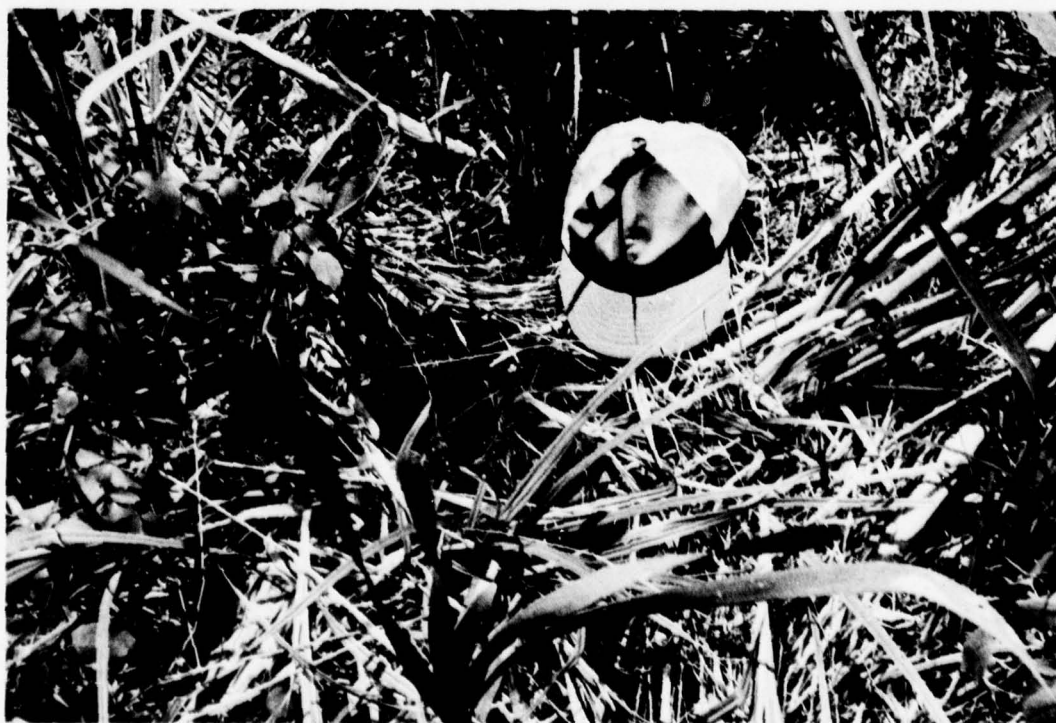
A 2 inch diameter plastic drain pipe was discharging approximately 0.8 g.p.m. at the time of the visual inspection. This pipe discharges at the toe of the embankment slope near the junction of the downstream embankment with the right abutment (see Photo 6). (This pipe is probably the "weep" installed in 1972 to drain the slide area.) An additional iron-stained seep, totaling less than 2 g.p.m., is present in this same area, down-slope from the slide. Combined, these seeps result in a small swamp to the right of the principal spillway. Surface drainage along the junction of the downstream embankment slope with the right abutment is not channeled properly and this water spreads across the slide area aggravating the situation. The slide area is hummocky and a 1 foot deep gully has been eroded near the base of the affected area.

PHOTO 6. Two Inch Diameter Drain Pipe Outlet

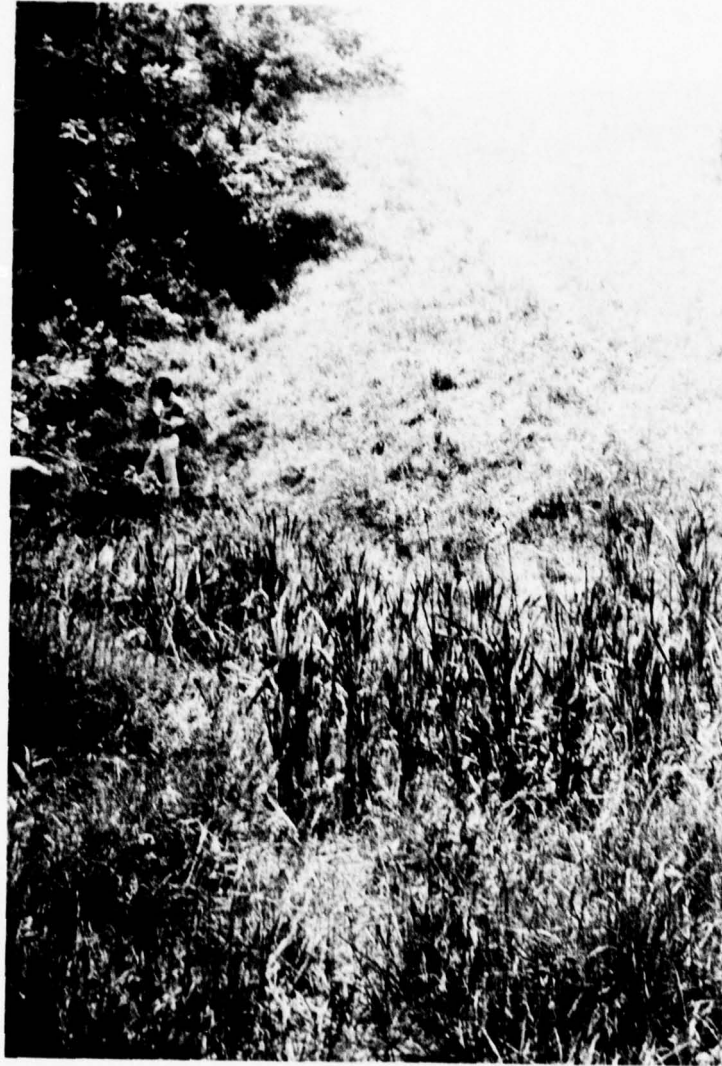
3.2 Evaluation: The most serious condition discovered during the field inspection was the zone of sloughing along the junction of the downstream slope with the right abutment. The sloughing of the embankment in this area and the corresponding seepage indicate a potential for piping failure and/or sliding failure of the embankment. Furthermore, since the seepage is not unusually high and no piping was evident, the sloughing may indicate an even more serious potential for embankment instability due to sliding. Although corrective measures were previously instituted, further remedial measures will be necessary to collect seepage and restrict sloughing.

PHOTO 7. Right Downstream Embankment Slide Area and Swamp
